# ROAD SAFETY AUDIT

Salem Road at South Street

Town of Tewksbury

October 28, 2016

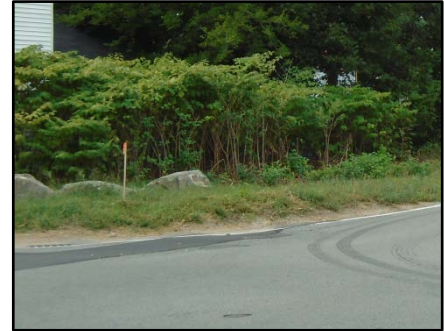
*Invasive Plant Species* – The property on the southwestern corner of the Salem Road / South Street intersection (#422 South Street) suffers from an invasive plant species known as Japanese Knotwood. The perennial weed is currently located on private property, but has spread onto Town of Tewksbury Right-of-Way (ROW) consistently in the past. The Town of Tewksbury Department of Public Works (DPW) identified that the weed is trimmed up to the property line twice each year; however, the sightline looking west from the South Street northbound approach can be limited severely by this weed as it grows back in between trimmings. Due to its large underground network of strong roots, the weed is resilient to above-ground cutting, continuing to re-sprout from its roots year after year. The crash reports indicated that 30 crashes at this intersection involved a vehicle travelling northbound along South Street and a vehicle travelling eastbound along Salem Road. The presence of vegetation overgrowth may have been a contributing factor in the crashes.

**Image 1: Trimmed Japanese Knotwood at the intersection.**

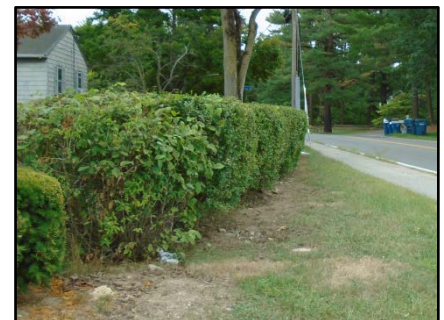
Northeastern Corner - In their current state, the bushes on the northeastern corner of the Salem Road / South Street intersection reduce the sightline looking east from the South Street southbound approach. In addition, a chain-link fence along the property line and a large utility pole located approximately 90 feet east of the intersection further restrict the sightline. During field observations and measurements, the ISD from the South Street southbound approach, looking east, was measured at 170 feet, which is well below minimum recommendations set by the AASHTO. At the design speed of

**Image 2: Bushes and utility pole seen obstructing sightlines on the intersection's northeastern corner.**

36 MPH<sup>1</sup>, the minimum recommended ISD is calculated at 260 feet with a desired ISD of 400 feet. The crash reports indicated that six (6) crashes at this intersection involved a vehicle travelling southbound along South Street and a vehicle travelling westbound along Salem Road. The presence of vegetation overgrowth may have been a contributing factor in the crashes.

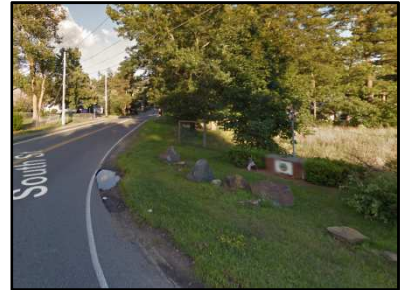
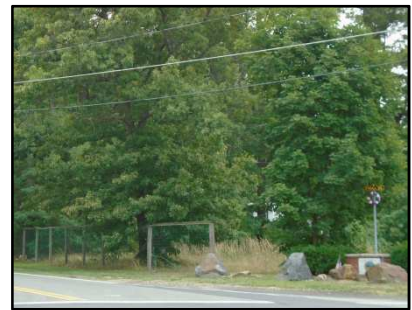
Southeastern Corner – A wood-framed fence with green plastic mesh is currently located on the southeastern corner of the Salem Road / South Street intersection. Drivers on the South Street northbound approach looking east are forced to look through the green mesh in the fence as they approach the intersection to see vehicles traveling along the Salem Road westbound approach. Per representatives of the Tewksbury Fire Department and Tewksbury Police Department, this fence was constructed many years ago for a whiffle ball field located on Town of Tewksbury property. At present, the whiffle ball field no longer exists, and the fence could be removed. In addition, tree branches from the nearby tree appear to sag low near the sight line.

**Image 3: 2013 view (above) vs. 2016 view (below) of whiffle ball field fence and vegetation along the southeastern corner. (Google Earth)**

The density of the vegetation has grown over past years as shown in the comparison of 2013 and 2016 views to the right. The crash reports indicated that 32 crashes at this intersection involved a vehicle travelling northbound along South Street and a vehicle travelling westbound along Salem Road. The presence of the mesh fence and vegetation may have been a contributing factor in the crashes.

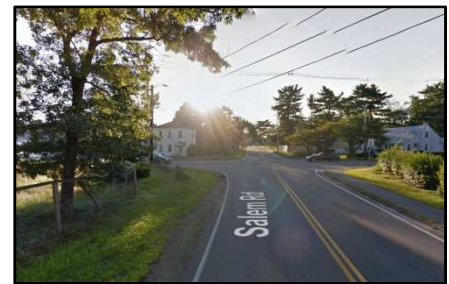
It was noted by a Town of Tewksbury Police Officer that solar glare currently makes it difficult for drivers to see along Salem Road westbound where the direction of travel and lack of overhead canopy invites direct sunlight onto the roadway. A prominent pattern in the crash data indicated 27% of the crashes occurred between 6:00PM and 9:00PM, the period in which glare may be an issue for Salem Road westbound vehicles. Only one (1) crash noted that solar glare contributed to the crash; however seven (7) crashes occurred along Salem Road westbound during this three-hour time period. The solar glare could also blind motorists entering the intersection from the South Street northbound and southbound approaches when they look westbound to see if it is safe to proceed into the intersection.

**Image 4: Solar glare along Salem Road westbound. (Google Earth)**

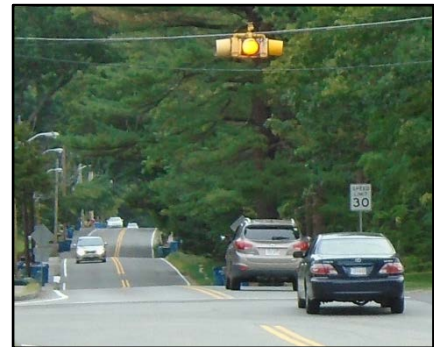
*Sags in Roadway Grading* – While Salem Road is relatively flat west of the Salem Road / South Street intersection, there are multiple sags in the roadway’s vertical curvature along Salem Road east of the intersection. Due to the multiple vertical curves along the Salem Road westbound approach, larger vehicles can block the view of smaller passenger cars operating immediately behind them. A vehicle stopped on either South Street approach waiting to pull into the intersection may believe that the right-of-way is clear after the larger vehicle passes through the intersection, creating the potential for an angled collision with the smaller passenger car traveling behind the larger vehicle. The crash reports indicated that 38 of the crashes noted at the intersection involved a vehicle travelling along Salem Road westbound. The presence of various sag and crest curves within the roadway profile may have been a contributing factor in these crashes.

**Image 5: Sags in roadway profile along Salem Road east of the intersection.**

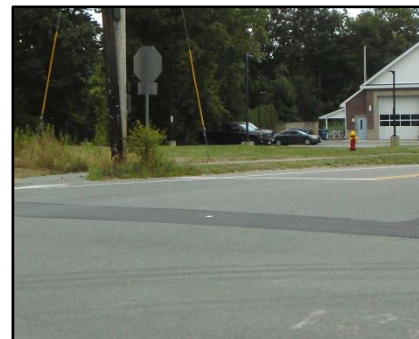
*STOP-Bar Too Far from the Edge of Travel Way* – The current STOP-bar on the South Street northbound approach is located 32 feet from the travel-way. Manual on Uniform Traffic Control Devices (MUTCD) provide guidance for STOP-lines to be placed a minimum

**Image 6: STOP bar on the South Street northbound approach is too far from the edge of the travel way.**

of 4 feet in advance of the nearest crosswalk line at controlled intersection, but should not be placed more than 30 feet from the nearest edge of intersecting traveled way. As observed during the RSA, numerous vehicles did not stop at the marked STOP -bar due to its extreme distance away from Salem Road; instead, these vehicles rolled through the STOP-bar and sign to the edge of the travel-way in order to see vehicles approaching from either direction on Salem Road. Assuming a vehicle was to stop at the current marking location, sightlines in both directions are nearly non-existent. Upon inspection, it appears that the STOP-bar and sign may be located at its current location due to the proximity of an adjacent utility pole. It was noted that the location of the STOP-line and sign may be related to maneuvers for a fire apparatus entering South Street from Salem Road. Moving the STOP-bar and sign to an appropriate location may force the sign to not be visible behind the utility pole or may affect the turning ability of a fire apparatus. The crash reports indicated that 59 crashes involved a vehicle travelling northbound along South Street. The location of the existing STOP-bar and signage away from the intersection, as well as vehicles tending to “roll” into the intersection for improved sightlines, may have been a contributing factor in the crashes.

1. Relocate the STOP-bar and STOP-sign south of the intersection closer to the intersection. This may require the relocation of the existing utility pole or the installation of a supplemental STOP-sign on the westerly side of the South Street northbound approach. Truck turns should be evaluated upon any movement in STOP-bar and signage.
2. Paint supplemental “STOP” pavement markings prior to the STOP-bar to reinforce the STOP-controlled condition on the South Street approaches.

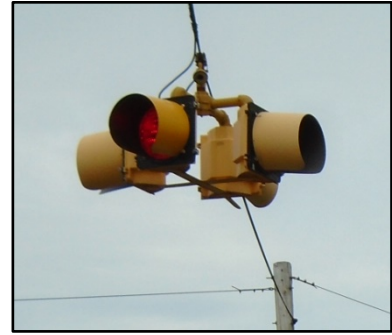
*“There is anecdotal evidence that suggests that the overhead beacons have been interpreted as indicating a four-way stop at locations that were in fact only a two-way stop. This has caused motorists to pull out in front of the approaching vehicles because they assumed the approaching vehicle would be stopping.”*

**Image 7: Overhead flashing beacons at the intersection.**

Due to the presence of flashing beacons on all four approaches, drivers operating on the South Street approaches may expect Salem Road cross-traffic to stop because they cannot see the yellow color of the flashing beacons on the Salem Road approaches. The intersection does currently have supplemental signage with STOP signs indicating that cross traffic does not stop. Two (2) crashes noted specifically that the driver of the vehicle along South Street believed the intersection to be a four-way STOP-controlled intersection when he/she proceeded into the intersection.

2. Paint supplemental “STOP” pavement markings prior to the STOP-bar to reinforce the STOP-controlled condition on the South Street approaches.
3. Remove the overhead flashing beacons from the intersection to reduce the potential misconception that the intersection operates under a four-way STOP condition.

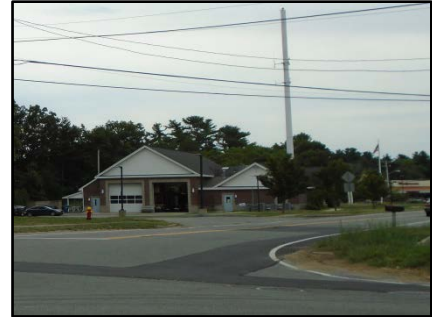
southwest corner of the intersection, a catch basin is located at the edge of pavement with no curbing/berm on the back side of the structures. Sand and gravel is clearly visible within the roadway which is a product of soil from the adjacent property flowing towards the catch basin during rain events.

**Image 8: Soil from adjacent property covering paved roadway shoulder on southwest corner of intersection.**

1. Consider isolated repair of poor pavement and curbing areas, such as the southwest corner of the intersection which currently does not include vertical curbing.
2. Consider a mill and overlay of the entire intersection and the several approaches with higher friction pavement.

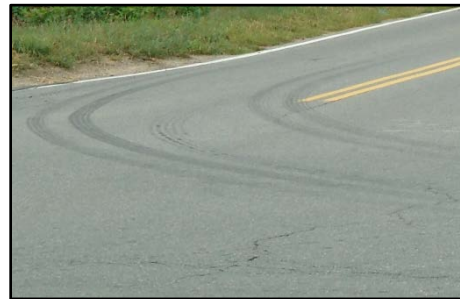
***Pavement Friction*** - On the morning of the RSA, the Salem Road / South Street intersection experienced rain showers that left the pavement wet and slick. No ponding was noted at the time. Prior to and again during the RSA field visit, vehicles were observed spinning their tires as they accelerated to cross the intersection after coming to a stop on the South Street northbound approach. During the RSA, an Audit representative noted that the overall pavement friction at the intersection may be low. It should be noted that 30 percent of the crashes over the four-year period occurred on wet pavement. The lack of friction combined with the wet pavement could be stalling the vehicle's forward momentum across the intersection as it attempts to cross the intersection within a visible gap in traffic.

**Image 9: Pavement skid marks at the intersection.**

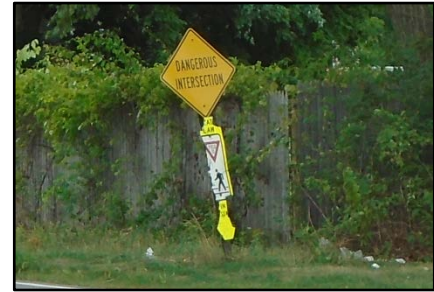
At the time of the RSA, two “Dangerous Intersection” signs were along each Salem Road intersection approach. It was noted by a MassDOT representative that these signs should be removed as they indicate safety issues with the intersection and place liability on the Town of Tewksbury.

**Image 10: “Dangerous Intersection” sign located on one of the intersection approaches.**

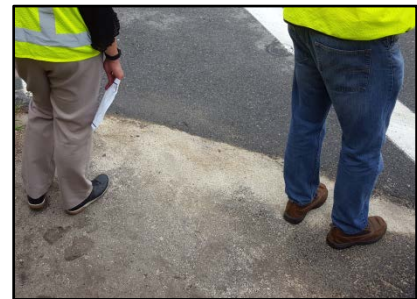
*Pedestrian Accommodations* - It was noted during the RSA that the intersection lacks ADA-compliant pedestrian accommodations, including accessible ramps, detectable warning strips or advanced pedestrian warning signage. Furthermore, RSA participants observed roadway debris accumulating where the current ramps meet the edge of the roadway. No crashes during the four-year study period at the intersection involved a pedestrian.

**Image 11: Lack of accessible curb ramps with debris on the intersection's northwest corner.**

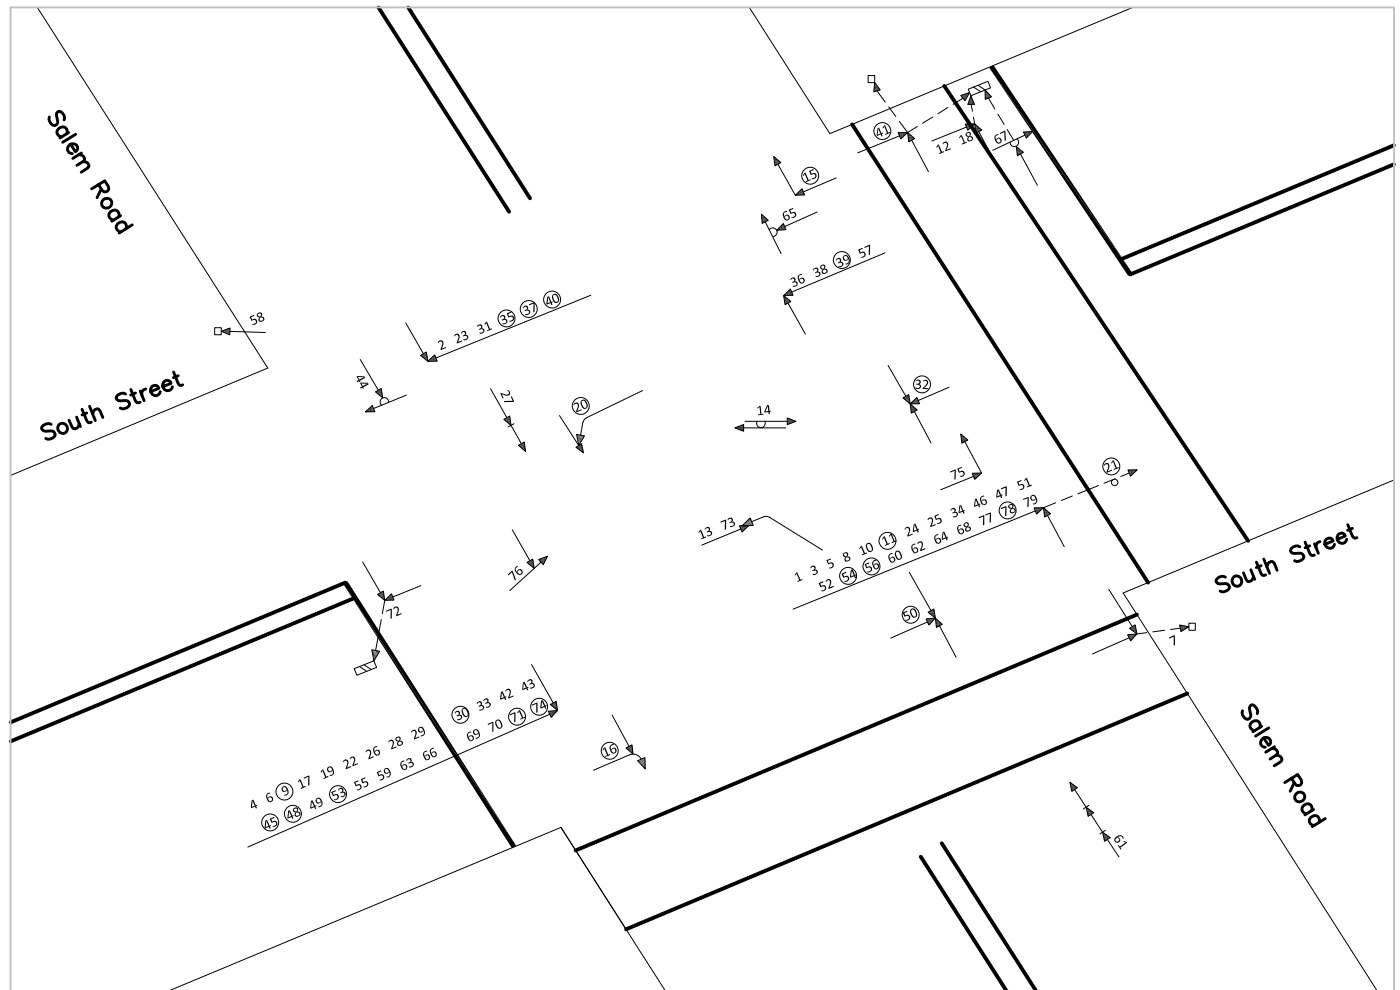
LOCATION: Salem Road @ South Street  
CITY/STATE: Tewksbury, Massachusetts  
TIME PERIOD: 2011- 2014  
PREPARED BY: TEC, Inc. / Eindra (Elena) Aung, E.I.T.  
SOURCE: MassDOT / Town of Tewksbury Police Department
